Landscape Summary

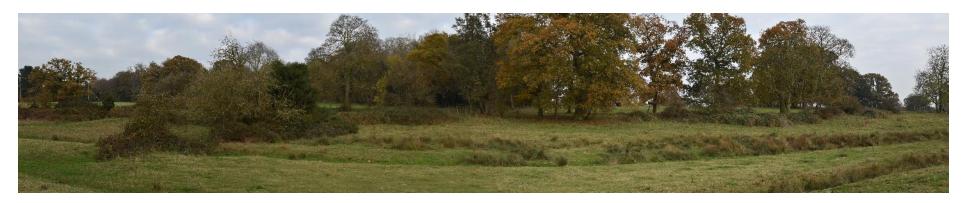
Figure 1. View to the northeast and parkland, Well Beck lies in the foreground

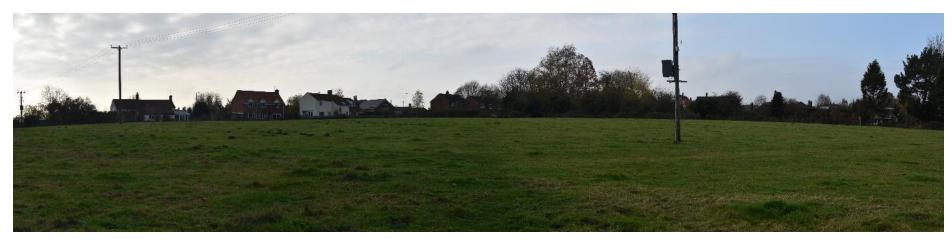
Figure 2. View to the west and the rear elevation of dwellings on the B1332, Porch House is surrounded by mature trees

Visual receptors include dwellings on the north and south western boundaries and to a lesser extent properties to the south on Bungay Road (B1332). These dwellings consist mainly of late 20th century detached homes infill development between older properties including the grade II* listed Porch House, 45m to the northwest of the site boundary. The most open views are from the rear elevation of properties along the south western edge, with some views from upper storey windows to the north west. Porch House is surrounded by mature trees within the garden reducing any visual relationship with the site. Further views from the interior of the Poringland are limited by structures and trees. There are glimpsed and partial views approaching the site along the tree lined Bungay Road. The only Public Rights of Way (PRoWs) affected is the bridleway along the southern edge. The closest national trail is Boudicca Way, which is 1.8km to the west.

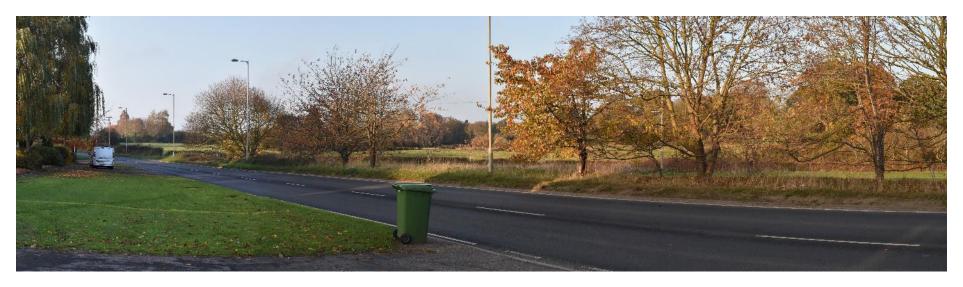
Figure 3. View to the north over the site from properties on the B1332, the road is tree lined as it approaches the village of Poringland

The western edge of the site is enclosed by a poorly structured mature hedgerow of mainly hawthorn, blackthorn and ivy along Bungay Road and to the rear of dwellings mainly close board fencing with an open aspect. The carriageway heading southeast is lined by maturing trees including cherry and maple. The existing site entrance is at the junction with Wash Lane, a bridleway along the southern boundary. The slightly sunken lane is lined by wellstructured banked hedgerows. To the north the site rises to the rear garden boundaries of dwellings along Rectory Lane. Mature trees within the gardens including conifer reduce views to the north and the rear elevations of the houses. The village of Porlingland extends to the north and north west of the site beyond Rectory Lane. The eastern boundary of the site is marked by mature trees including oak and ash set along an open field boundary in parts. Beyond the tree line are parkland trees within pasture. The site is currently pasture and Well Beck passes through he eastern portion of the site on lower ground. The watercourse was barely flowing at the time of survey and the two channels are clogged leading to marshy land. To the centre of the site is a dry pond surrounded by two lines of unmanaged hawthorn that may be remnant hedgerows. A low voltage powerline crosses the site from the north to south crossing the B1332. The site falls approximately 7m from the north western boundary to the southeast corner, with a fall to the northeast as well to Well Beck.

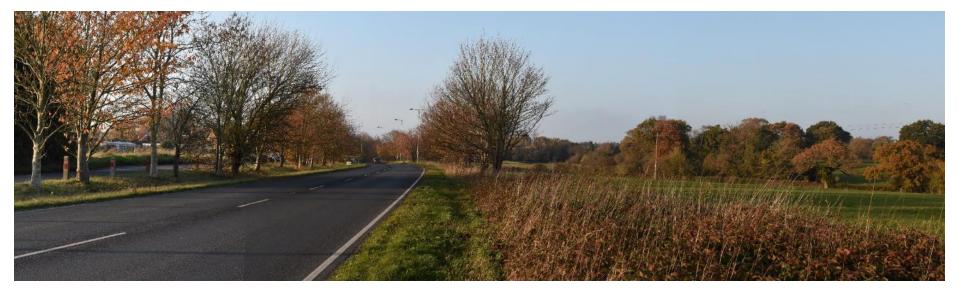
Figure 4. View to the northwest approaching the site along the B1332, the site is glimpsed and views are partial

Proposed mitigation recommended at this initial stage of design include: maintaining a public open space to the southern edge of the field which will soften the approach to the town along the B1332; attenuation of surface water runoff in the form of swales and a dry pond at the centre of the site; managing the channels of Well Beck as open space and natural marshland; continue the screening to Porch House along the rear gardens of properties on the B1332; orientate proposed dwellings to the northeast to exploit parkland views; enhance and maintain strong vegetation on the western edge introducing trees to continue tree line into town. The design and layout of housing will seek to accommodate these recommendations.
